**MILITARY SEALIFT COMMAND****LIFEBOAT SAFETY**

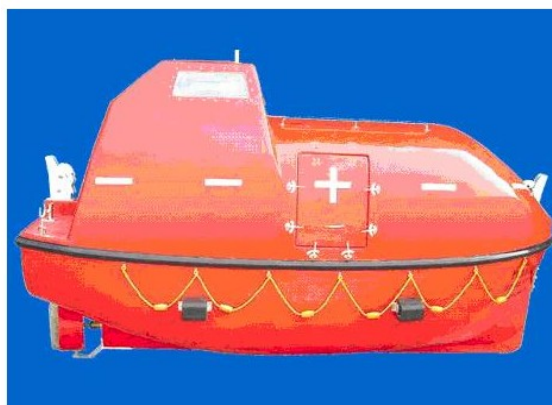
During a recent U.S. Coast Guard inspection, an MSC oiler experienced an inadvertent release of the forward hook assembly while lowering the lifeboat. This caused the lifeboat to dangle from the aft hook assembly momentarily before the lifeboat plunged into the water. An investigation into the cause of the mishap was then initiated. The focus of the investigation revolved around the lifeboat's releasing gear and the forward hook assembly. This mishap is one of many in recent years that have highlighted a growing concern in the international maritime community over the number of incidences involving lifeboats.
